**Salmon River Enhancement Society**

**Information Request**

**Trans Mountain Expansion Project (Project)**

**Marvin L. Rosenau**

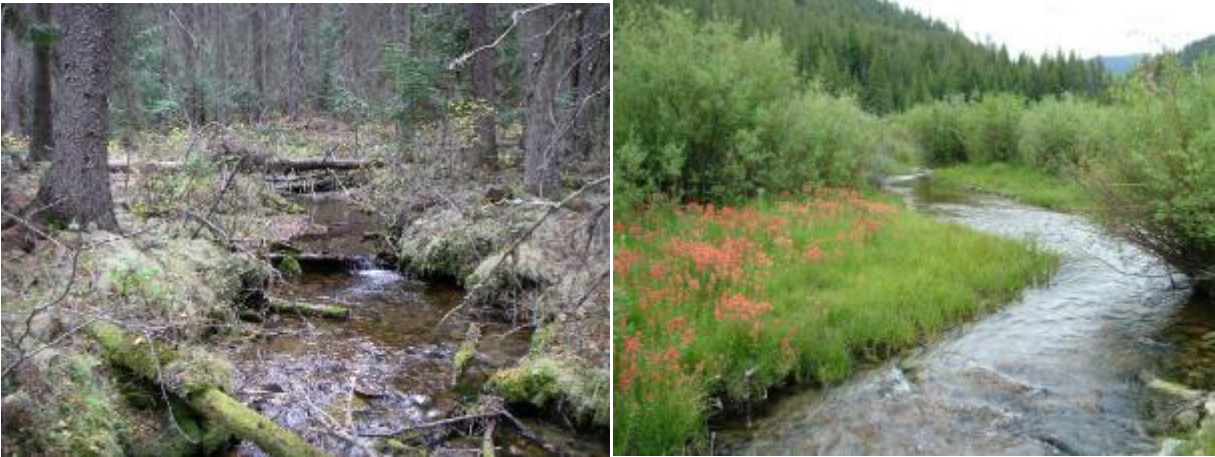
Figure 2 Streams with intact riparian areas. Left photo from Tschaplinski and Pike (2009); right photo from <http://deq.mt.gov/wqinfo/wetlands/RiparianWetlands.mcp> accessed July 7, 2015.

A riparian zone, or riparian area, is the water/land interface between the terrestrial upland area and a river or stream (Figure 1). Plant communities along the edge of streams or lakes are usually referred to as the riparian vegetation (Figure 2). The plant community within a riparian area often is dominated by hydrophilic species, but not always (Figure 2). In British Columbia watercourses that support CRA fisheries rely profoundly on intact and functional riparian areas (viz., Forest and Range Practices Act <https://www.for.gov.bc.ca/code/> Table 1; Riparian Areas Regulation <http://www2.gov.bc.ca/gov/content/environment/plants-animals-ecosystems/fish/riparian-areas-regulation> Table 2).

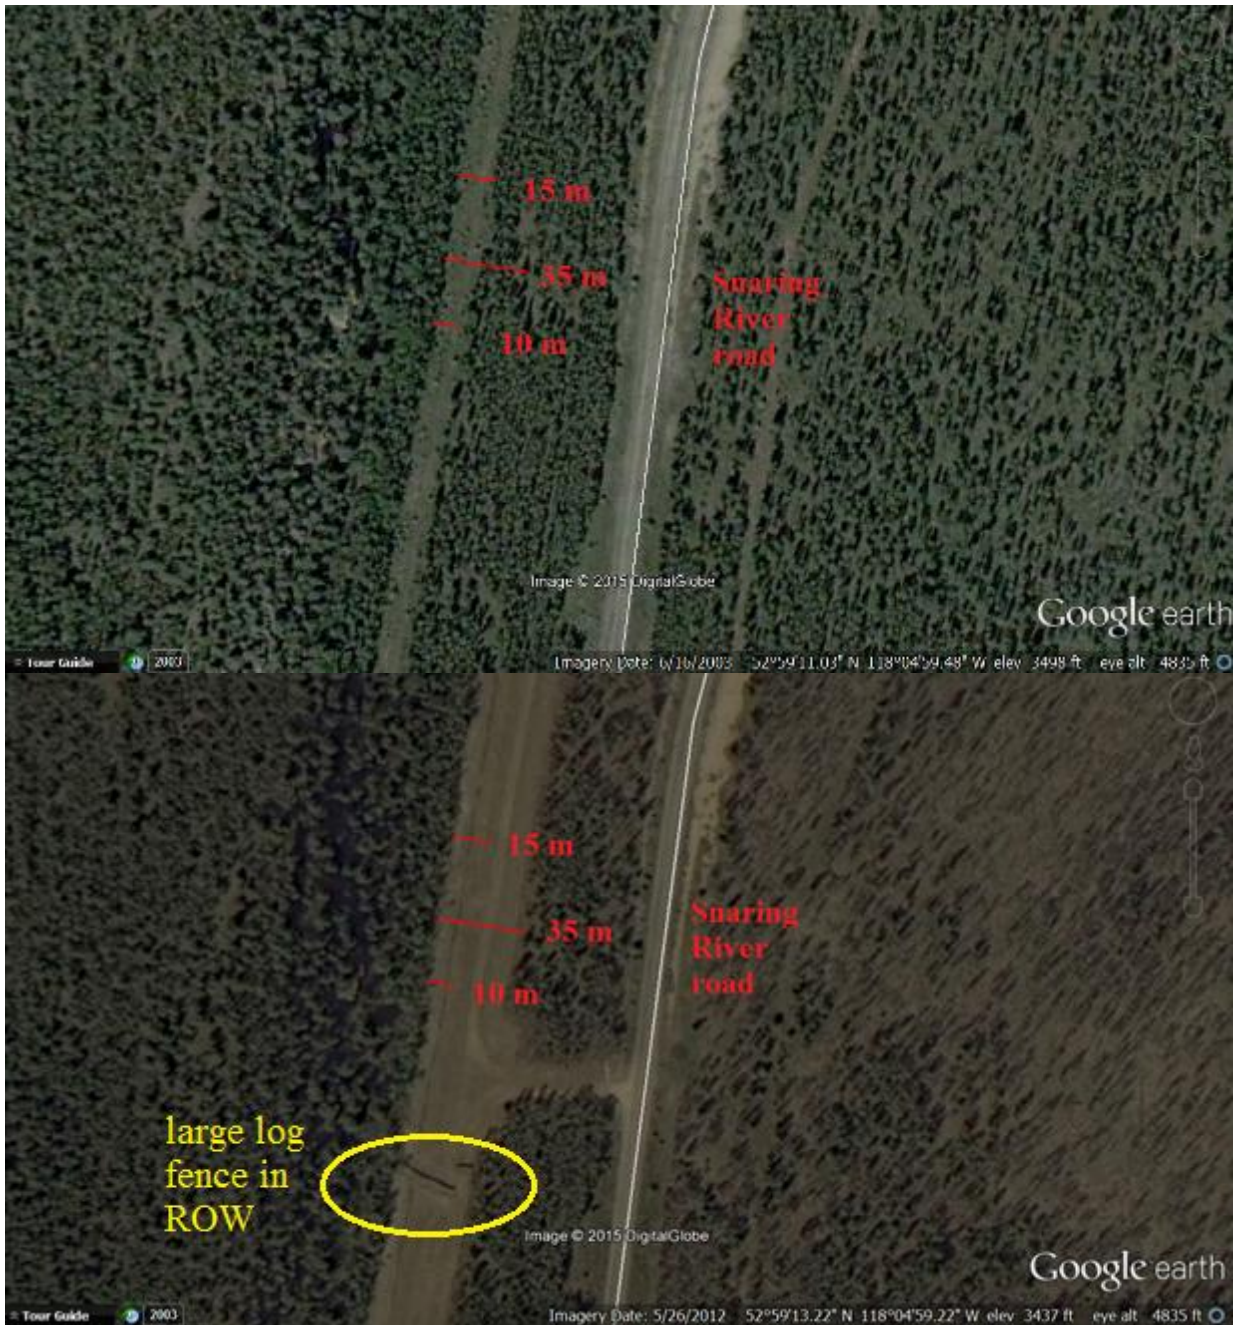
Figure 4a A comparison of the Trans Mountain Pipeline Anchor Loop pipeline project pre-construction versus post-construction vegetation communities showing large-scale habitat damage caused to the terrestrial landscape as a result of vegetation clearing in the construction and ROW corridor approximately 2.6 km south of Snaring River. This Google Earth location was chosen for illustrative purposes to show the TMP unmitigated damage to the terrestrial landscape in Jasper National Park because of the ground level photos that were available for comparison. Top photo was taken June 16, 2003, prior to construction (2004-2008) while bottom photo shows extent of the unmitigated vegetation damage as of June 26, 2012. Compare these photos with Figures 5, 6, 7 to see ground level extent of natural vegetation losses. See also, Figure 11.

Figure 4b Random example of extensive losses of old-growth montane-community trees, in addition to lower-level vegetation that colonized the ROW since 1953, in the terrestrial portion of Jasper National Park as a result of clearing in the corridor as part of the TMP Anchor Loop. Location is approximately 1 km south of Snaring River. Top photo: 2003; Bottom photo 2011. There is no indication that TMP ever adequately mitigated or compensated for these extensive terrestrial losses of old-growth large vegetation in this national park.

An examination of various locations of the pipeline corridor of the Anchor Loop shows a wide (often ~40 m) swath through the native vegetation with little structural (either the soil or rock, or vegetation) diversity (Figures 4, 5, 6). The 2003 air photo near Snaring River (Figure 4, upper photo) in the Anchor Loop ROW shows that there had been a measure of historic ecological “recovery” from the 1953 impact with the growth of low shrubs, etc,. However, by 2008 this vegetation had been destroyed by the Anchor Loop project (Figure 4, lower photo). Furthermore, the corridor width of the damage to the terrestrial vegetation had been expanded extensively, by ~20 m, into the previously-untouched forested areas (~15 m to ~35 m). By 2012 (Figure 4, bottom) and 2015 (Figures 5, 6) no meaningful vegetation recovery had taken place and any vegetation planting that did occur appears to have both not matched the local plant community or had largely failed (Figure 7). Specifically, there does not seem to have been a mitigation plan for the loss of large trees where the Anchor Loop encroached into “virgin” timber (c.f., Figure 4 with Figures 5, 6, 7).

Anchor Loop project it is very clear that there was large-scale clearing of older, mature vegetation (trees and shrubs) as well as younger plants that had recolonized the disturbed zone from 1953 and onwards (c.f., Figures 4, 5, 6, 7). There is no evidence in the ROW or putative construction zone that any significant recovery has occurred since 2004-2008. Furthermore, there is no evidence that TMP or its restoration consultants put in any effort to replace the biodiversity that was extant prior to construction (Figures 5, 6, 7).

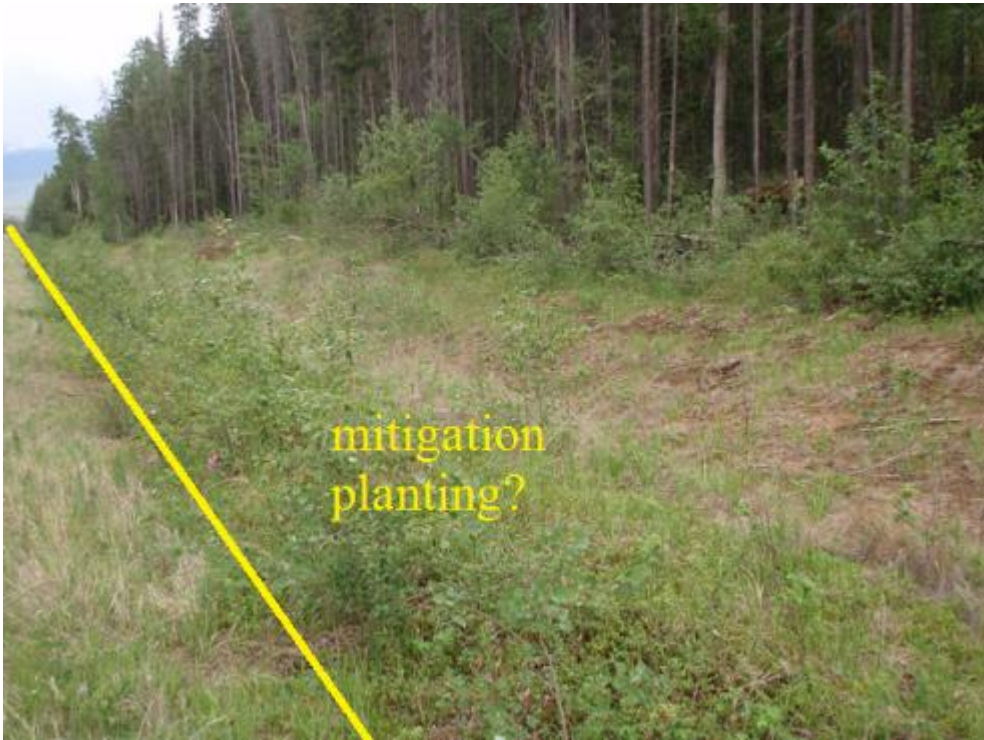
Figure 7 Putative-vegetation mitigation planting by TMP, along the perimeter of the forested area, within the presumed construction-zone portion of the Anchor Loop. This is a current ground-level view of extreme habitat damage due to the Trans Mountain Pipeline Anchor Loop pipeline project caused to the terrestrial landscape as a result of vegetation clearing in the construction and ROW corridor approximately 2.6 km south of Snaring River, looking south. Photo was taken June 19, 2015 approximately seven years after the end of the stated construction period (2004-2008). The strip of slightly higher (~knee height) vegetation is, presumably, the mitigation for impacts seen to pre-construction vegetation community seen in Figure 4a (compare the upper, pre-construction, photo to the lower, post-construction, photo which shows the extent of natural vegetation pre-densities and post-losses). Note that if this meant to be “mitigation” for ecological losses the vegetation does not mimic the perimeter plants. Presumably there is no longer any assessment as the density of plants appears to be minimal, compared to a thriving vegetative community, given how poorly these plants are growing in the 10 m strip along the forested zone.

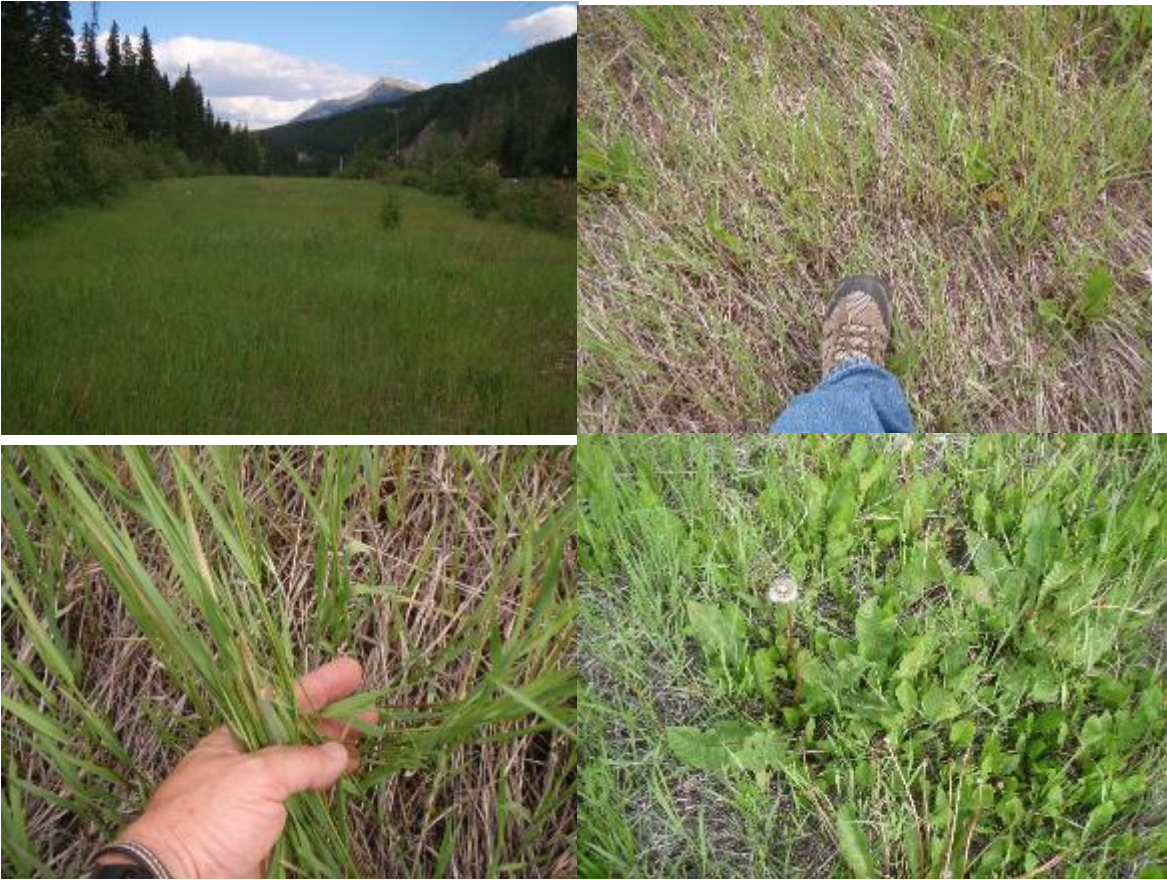
Figure 8 Trans Mountain Pipeline Anchor Loop corridor near Clairvaux Creek looking east (top left photo) including close-up of the dominant vegetation community (top right and bottom left photos) including dense patches of invasive species (bottom right). Note the extreme homogeneity of the landscape, both physically and in regards to vegetation community. Photo taken June 21, 2015.

At another location, at Clairvaux Creek, the homogeneity of the landscape and vegetation is apparent (Figure 8). The lack of biodiversity is stark in contrast to the adjacent, untouched, forested area. In large part, the ROW was dominated by a smoothed-over soil and a mono-culture of grasses as ground cover. Significant patches of invasive species (dandelions) could be seen mixed in with the grasses. Similarly, at Meadow Creek the damage to the landscape in both the riparian and terrestrial areas was extensive with little or no attempt at mitigating the biodiversity losses.

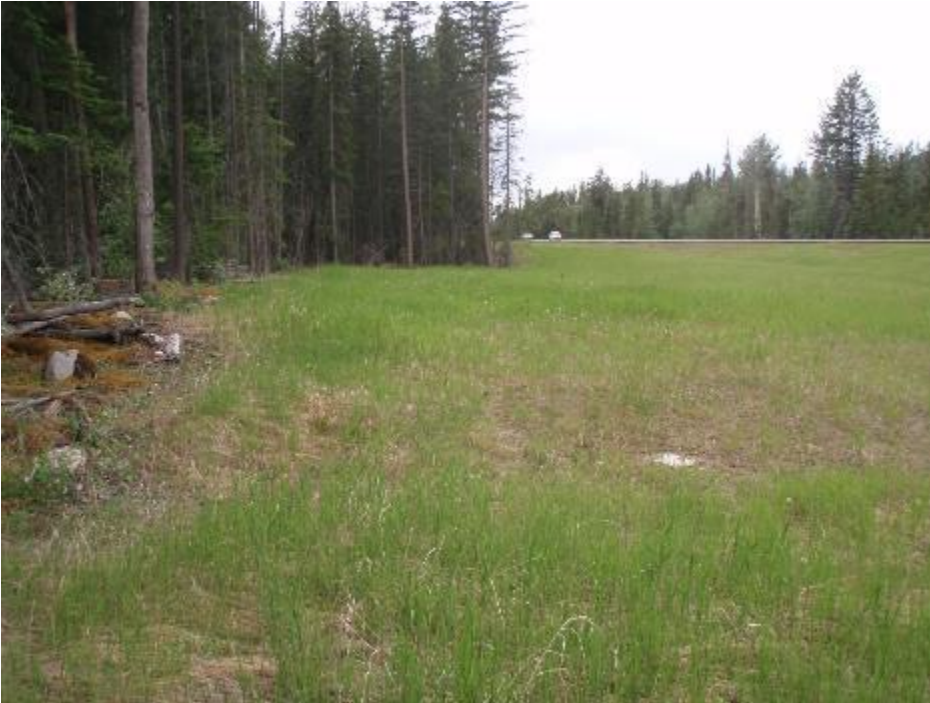
Figure 9 Heavily-impacted riparian and terrestrial habitats at Meadow Creek, Jasper National Park, on the true-left bank This section of the ROW was part of the Anchor Loop project. Note the lack of any apparent attempt by TMP at mitigating the destroyed vegetation community or at providing organic or landscape structure. It is not clear why such devastation was allowed in a national park. Photo taken June 19, 2015.

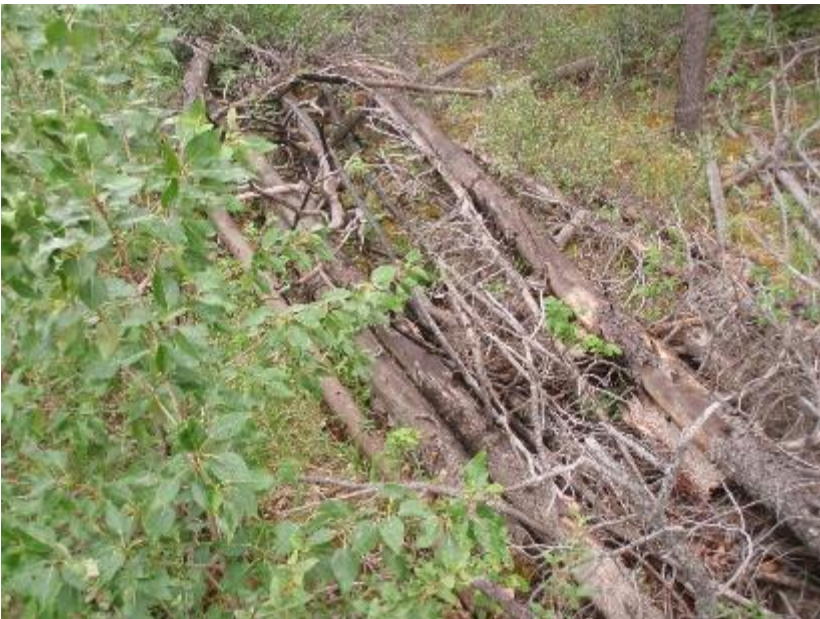
Figure 10 Very small diameter coarse woody debris left along the margin of the Anchor Loop pipeline corridor south of Snaring River approximately 2.6 km. It is not clear if this material was simply discarded from the ROW and construction zone or intended “mitigation” to provide physical and biological diversity to the Anchor Loop. In any event, this material was simply piled in a windrow with not apparent thought to providing habitat for small vertebrates or other species. Photo taken June 19,

2015.

It should be noted that there may have been a very small attempt to provide some physical diversity to the Anchor Loop ROW. For example, at the location 2.6 km south of Snaring River, at a few spots someone had dumped, in a windrow, some small woody debris (Figure 10). This may have been an attempt to offset lost habitat for small vertebrates. At another nearby location, a large log “fence” was constructed across the ROW (Figure 11). There were more than one of these structures built on the ROW.

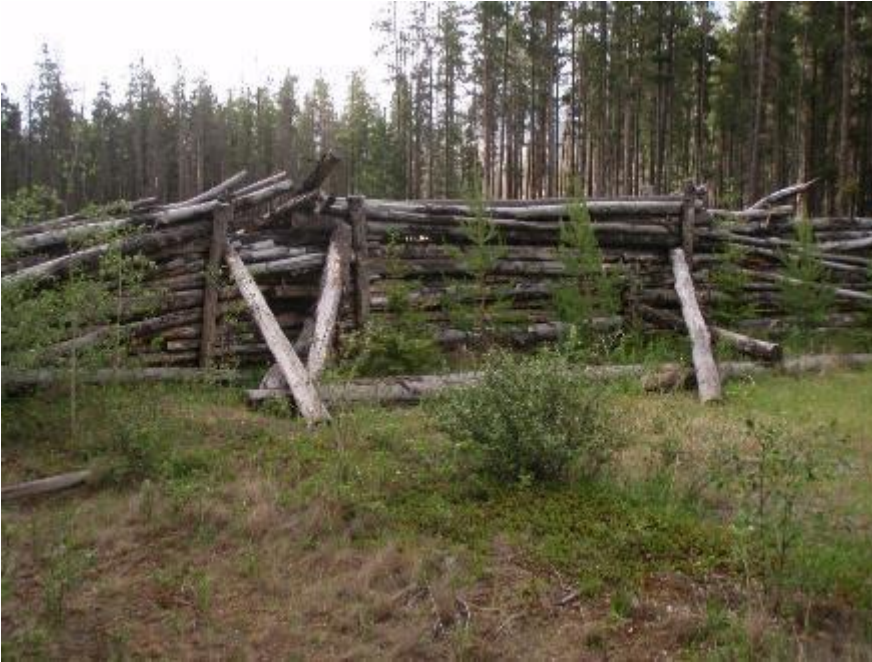
Figure 11 Large wooden structure located across the Anchor Loop corridor 2.6 km south of Snaring River. A number of these were constructed in the TMP ROW in Jasper National Park. Photo taken June 19, 2015.

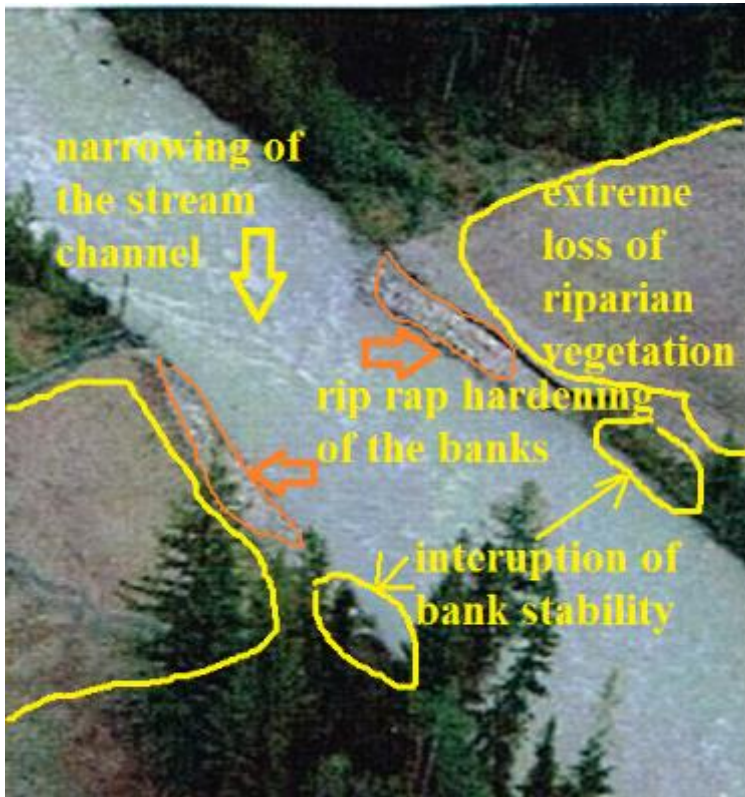
Figure 12 Extensive damage to the stream bank and riparian areas at a Trans Mountain pipeline crossing putatively in the Anchor Loop TMP project. For all intents-and-purposes, and from a fish-habitat perspective, this stream crossing can be viewed as a “biological scorched-earth zone”. Figure adapted (notations on photo, SRES additions) from May 19/20, 2015 TMP information meetings (presentation powerpoint by Calum Bonnigton).

There are many visual illustrations of the extensive, unmitigated, damage caused to streams with CRA fishes, by TMP, in the Anchor Loop. Perhaps the most interesting are two examples provided directly by TMP and its consultants for the Mount Robson Provincial Park portion of the project (Figures 12, 13) (they may be the same location). It can be seen that TMP extensively damaged the riparian area in these two figures. It is not known what date the photos were taken on, or if the damage was mitigated.

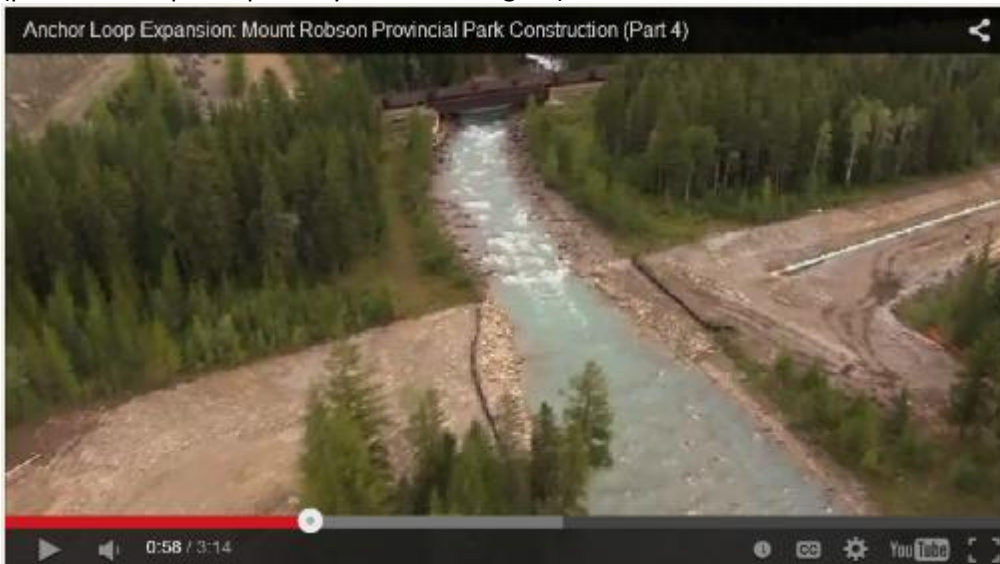
Figure 13 Extreme riparian habitat damage to a stream in Mount Robson Provincial Park in the 2004-2008 Anchor Loop project. It is not clear how or why the regulatory agencies would allow such an egregious impact in such a sensitive area. Taken from: <http://www.transmountain.com/anchor-loop-construction> and accessed July 10, 2015.

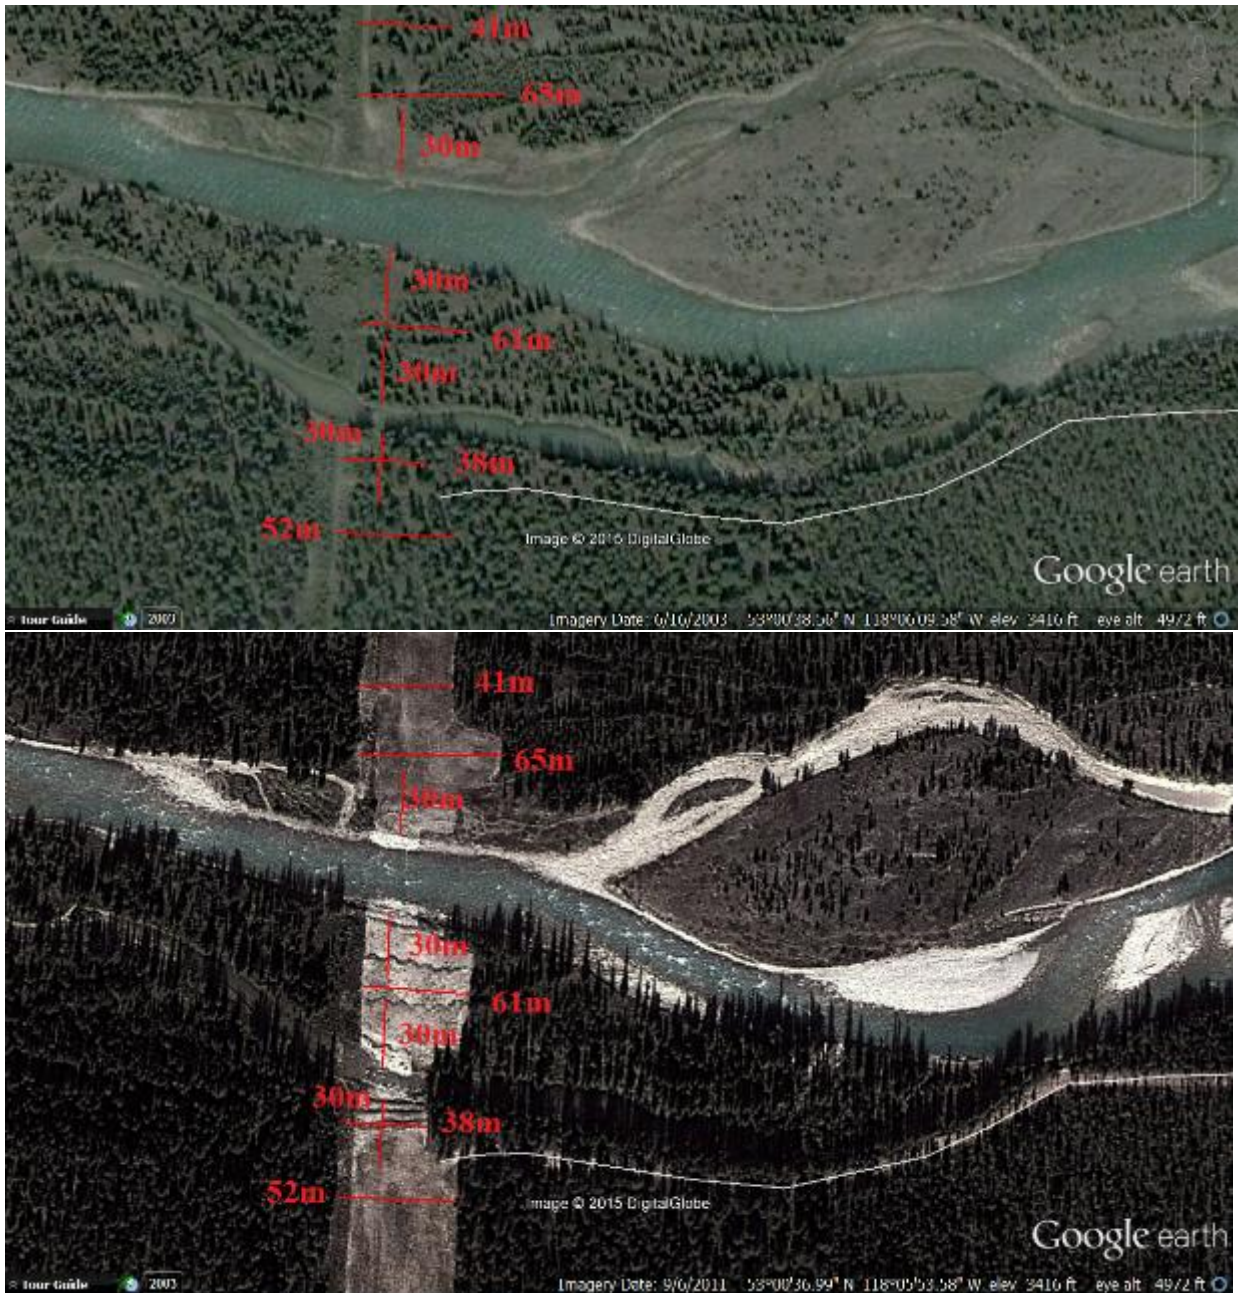
Figure 14 Extreme and extraordinarily unmitigated fish-habitat damage in the riparian areas of Snaring River and side channels caused by the Anchor Loop construction. Top photo shows Google Earth air photo taken June 16, 2003, prior to the Anchor Loop construction; bottom photo shows Google Earth air photo taken September 6, 2011 three years after the end of construction. Note the extensive amount of live large-woody vegetation within the 30 m riparian zone, in 2003, that was destroyed between 2004-2008. Note, as well, the profoundly impacted impacts to ephemeral channels within the island. Finally, note, that in many instances the vegetation removal far-and-away exceeds the 45 m corridor widths indicated by TMP at the public meetings and in the TMEP documents. Distances determined from Google Earth app.

A site that was not mitigated and comprised an example of large-scale damage in the Anchor Loop project was the crossing at Snaring River in the Jasper National Park (Figure 14). At this site, the crossing entailed the passage of the pipe through the main channel, a secondary channel (and across an island) and a number of ephemeral tertiary streams. Major losses of riparian vegetation occurred as a result of the pipeline construction.

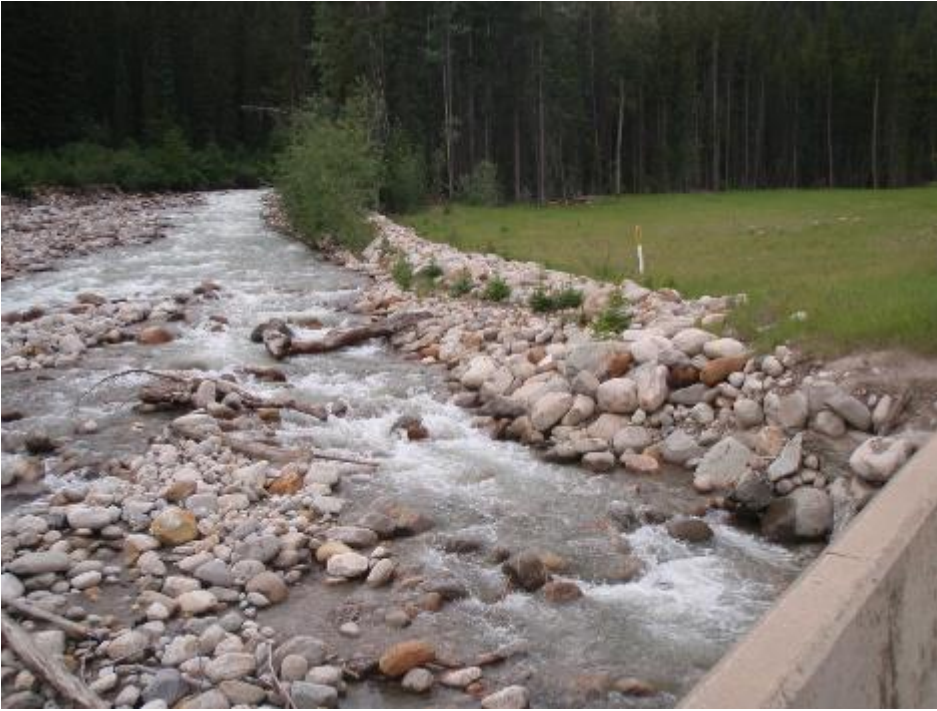
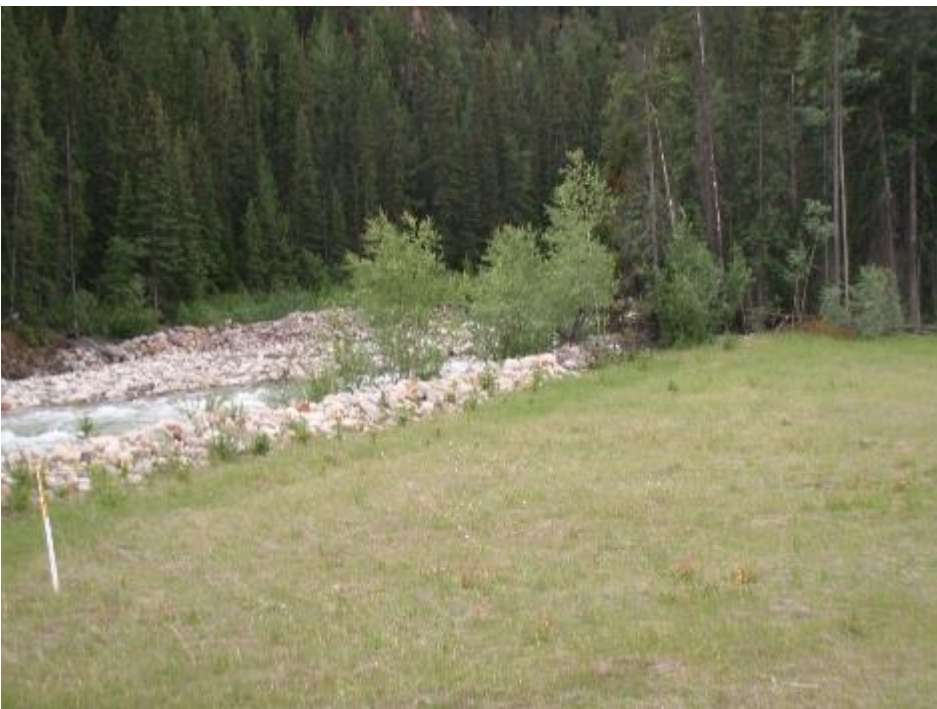
Figure 15 Extreme damage to the left-bank riparian area of Meadow Creek as a result of the Anchor Loop project. Middle photo: taken from highway bridge looking upstream; Bottom photo: looking from left bank across the stream to the right bank upstream of the highway. There was no observable structural mitigation by TMP to either the instream channel or the bank integrity. No observable riparian vegetation was planted at this location (outside of grasses). The coarse sediments are simply being windrowed along the banks of the stream as a form of armoring without any due consideration to instream or bank-habitat complexing. Photo taken June 19, 2015.

Major unmitigated losses to stream habitats, as a result of the Anchor Loop, have also been observed at Meadow Creek (Figures 15, 16). This site was complicated, of course, by the proximity to the highway crossing which was immediately downstream of the pipeline crossing.

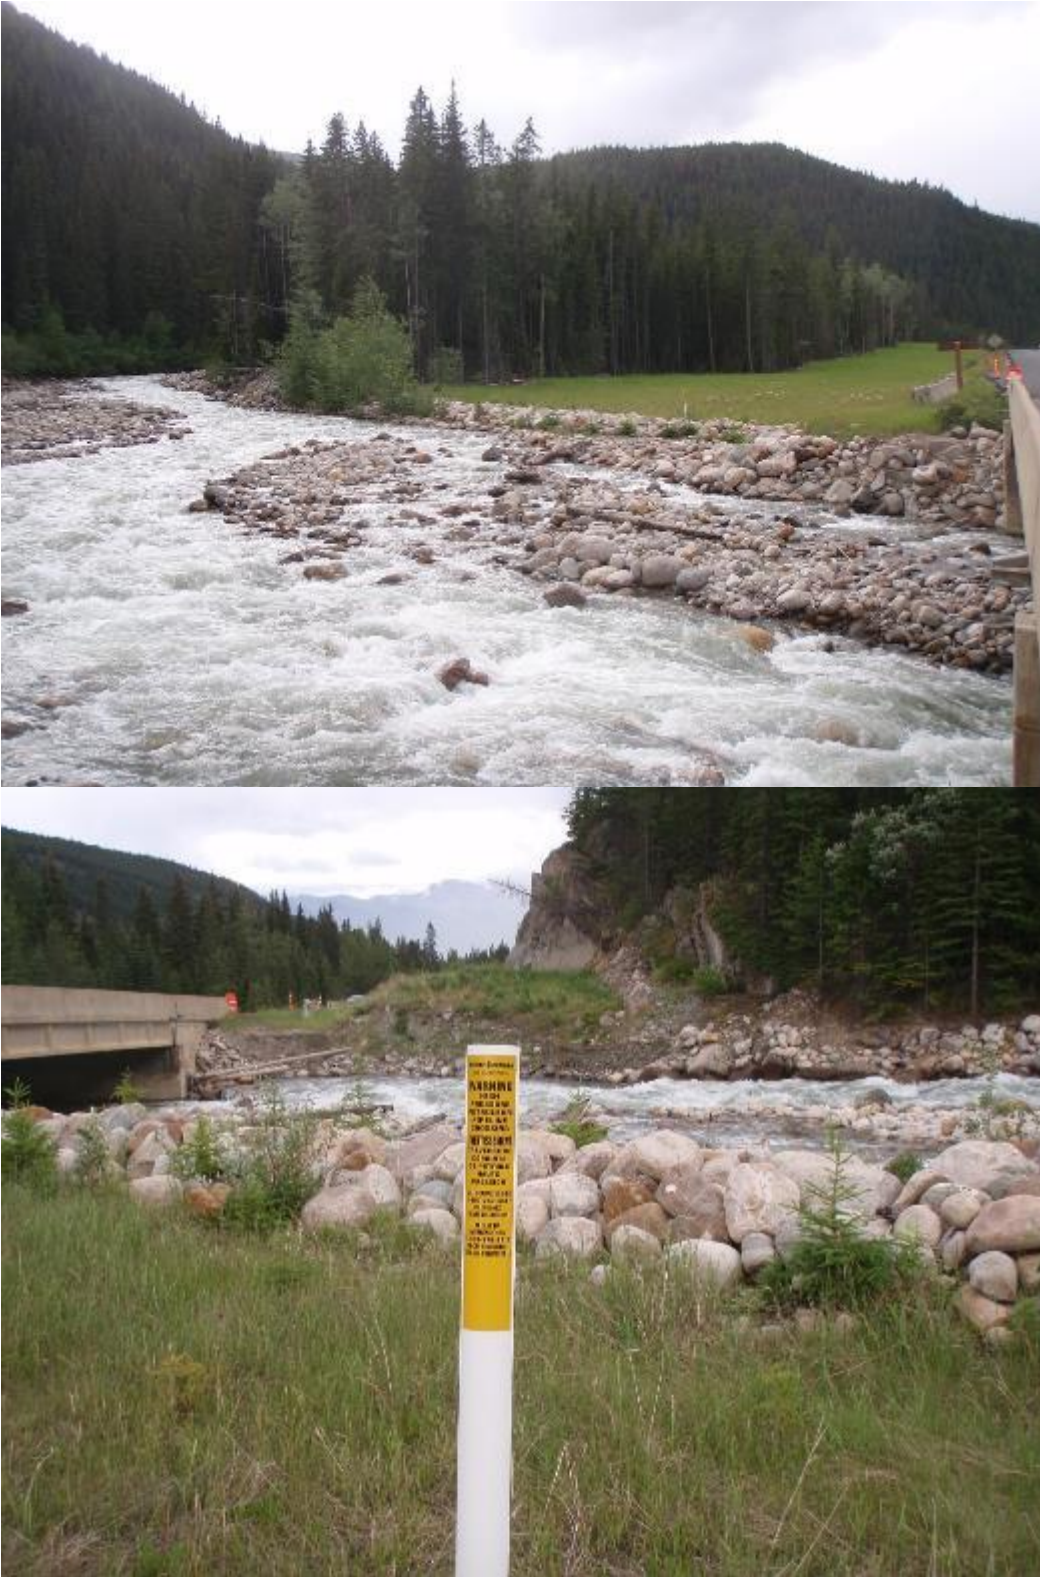
Figure 16 Extreme and unmitigated damage to the instream, bank and riparian areas for both stream-sides on Meadow Creek in Jasper National Park as a result of the TMP Anchor Loop project. Photo taken June 19, 2015.

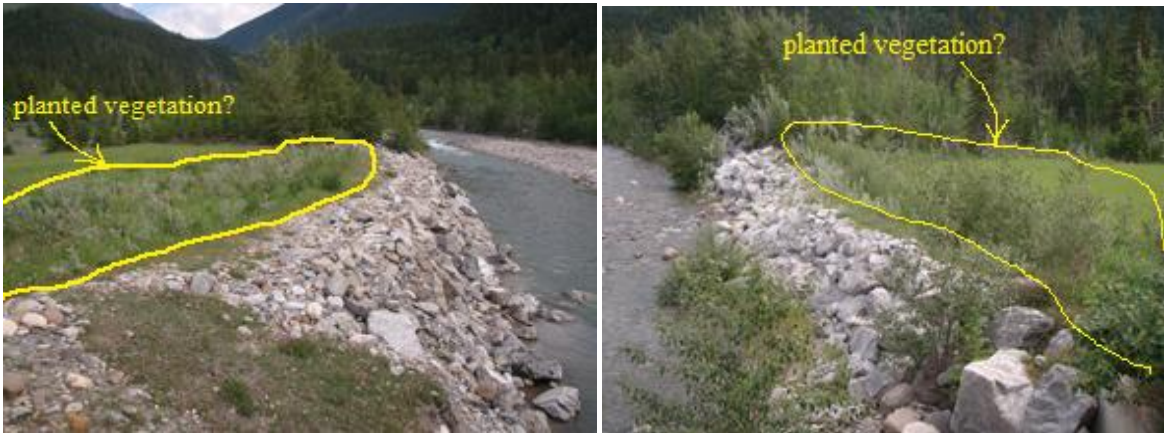
Figure 17 Right- (left photo) and left-bank (right photo) Fiddle River TMP crossing in the Jasper National Park section of the Anchor Loop project. Large-scale destruction of the shoreline integrity (riprapping) occurred here without any attempt at creating any instream or bank physical diversity. Unlike Meadow Creek, however, it appears that ~10 m of vegetation was planted along the riparian areas of this stream on both banks; nevertheless, it is clear that some of these shrubs/trees failed to properly survive and since 2008 most are only about knee-to-waist height (Figure 18).

There appeared to be an attempt, by the Anchor Loop project, to provide a modicum of riparian planting on the Fiddle River (Figures 17, 18, 19). The planting of vegetation can be seen to be very sparse and appears to have failed in patches.

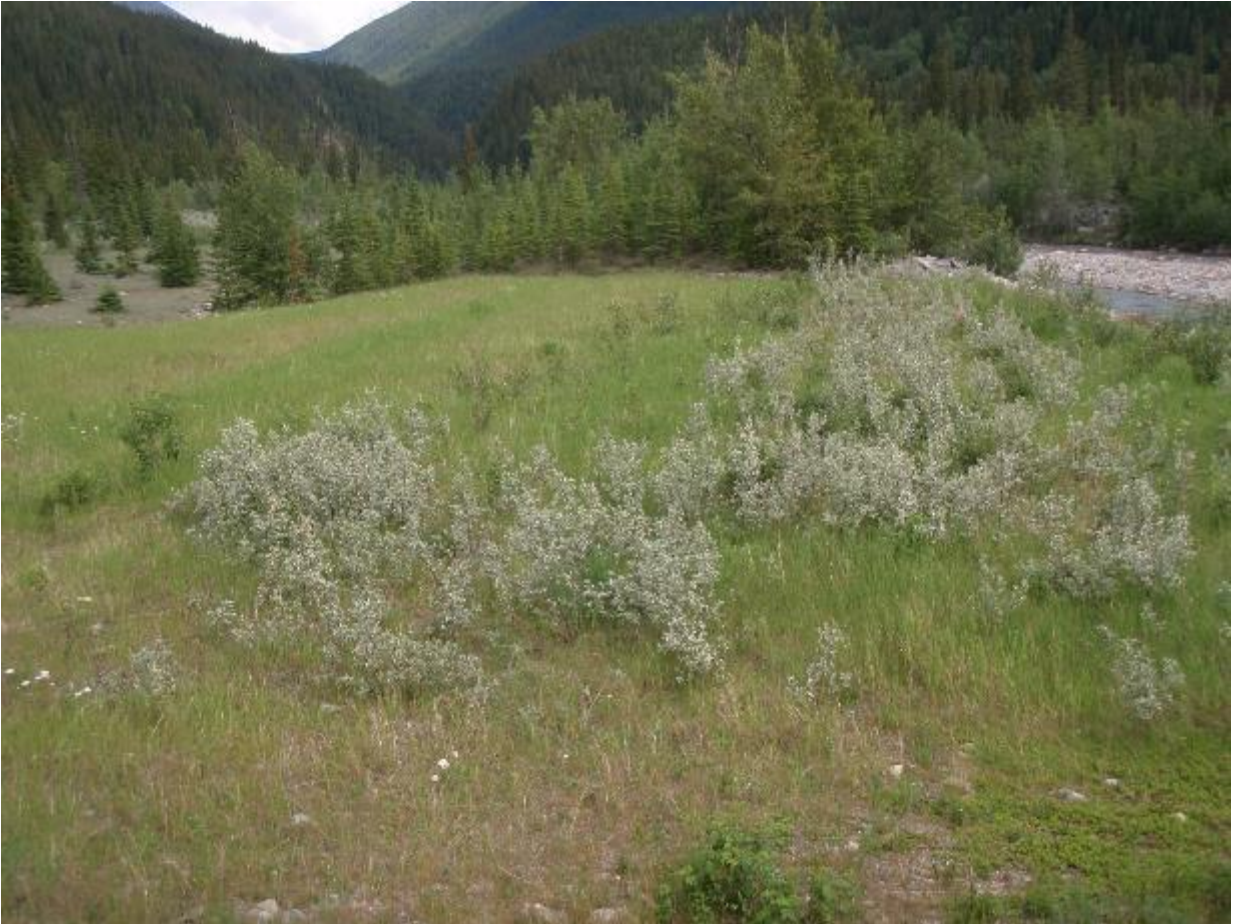
Figure 19 Right bank vegetation (looking upstream from the highway) at the TMP crossing at Fiddle River on the Anchor Loop in Jasper National Park. Note that there are large sparse patches that may have indicated that some of it has failed. Note, as well, that the species composition is very different than the natural vegetation community just upstream of the crossing.

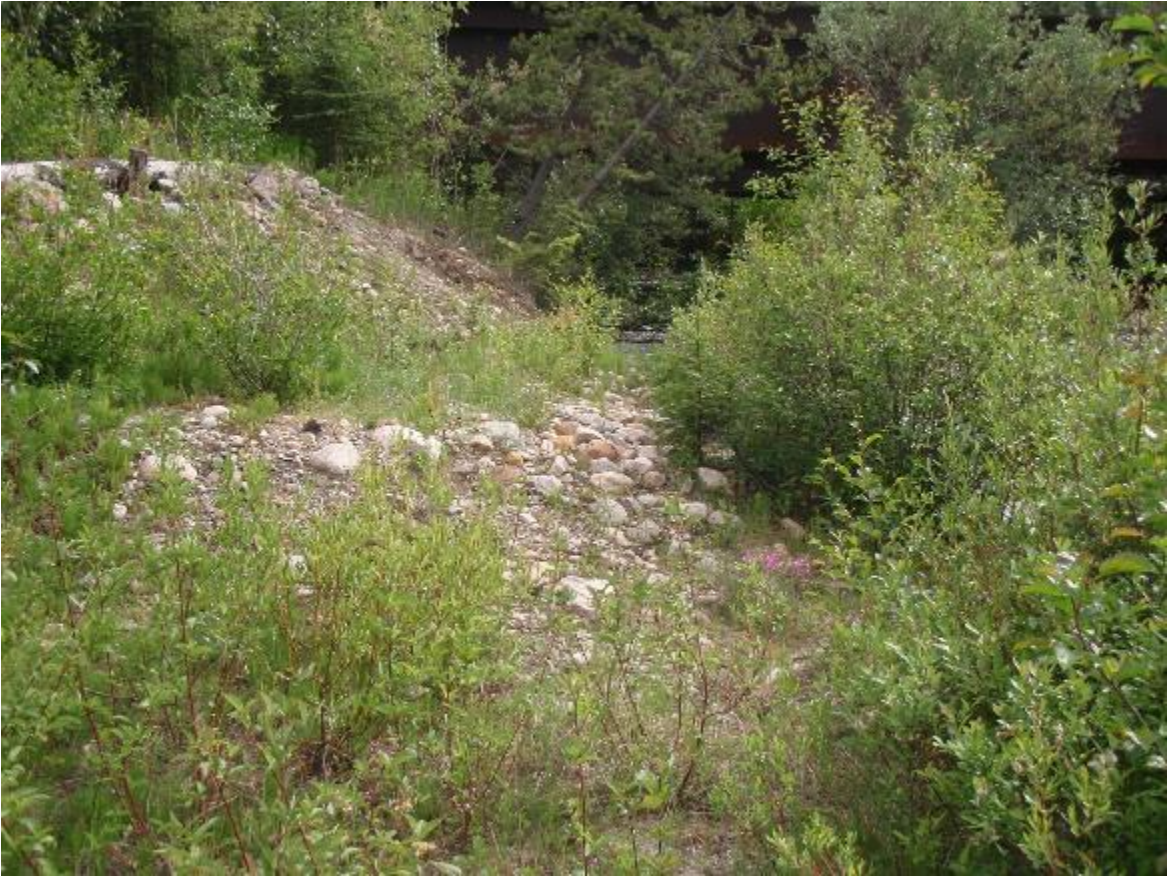
Figure 20 Left bank of Clairvaux Creek looking downstream in the Anchor Loop section of the TMP ROW. Vegetation along the bank and in the riparian area varies from moderate, to sparse to non-existent. Species of trees may have been planted but are mostly breast height or less. The plant diversity did not match the downstream, un-impacted stream. Even though the TMP ROW on this stream crossing is downstream of both the rail tracks and the highway, both banks have been bermed and this disrupts the natural fluvial processes.

Another attempt at mitigation was observed at Clairvaux Creek in the Anchor Loop within Jasper National Park (Figures 20, 21). Some vegetation appears to have been planted, but this may have been feral in nature. The banks had been bermed in order to entrain the flows in a laminar direction across

the ROW (Figure 20) disrupting any possibilities of retaining normal bank, floodplain or riparian physical fluvial processes.

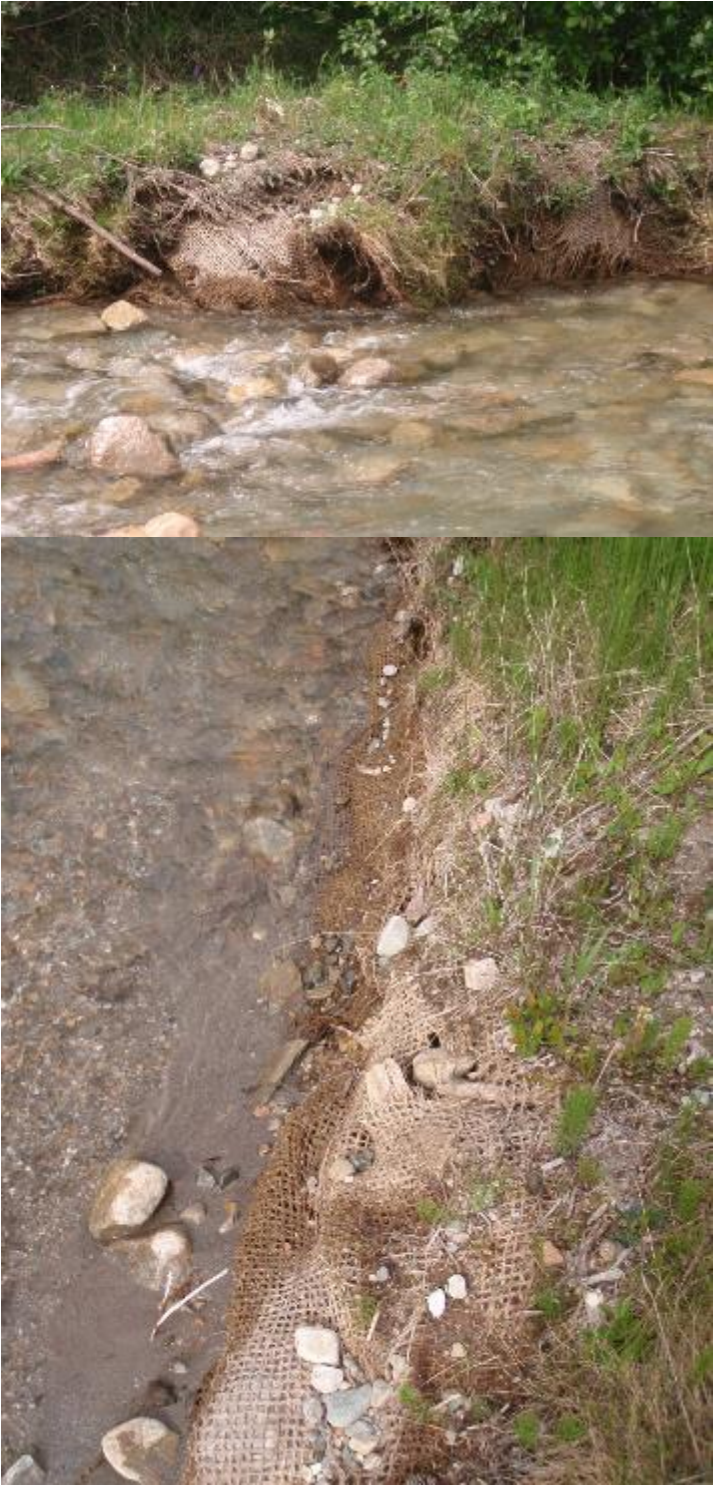
Figure 21 Coco-mat debris remaining at Clairvaux Creek from the TMP Anchor Loop construction.

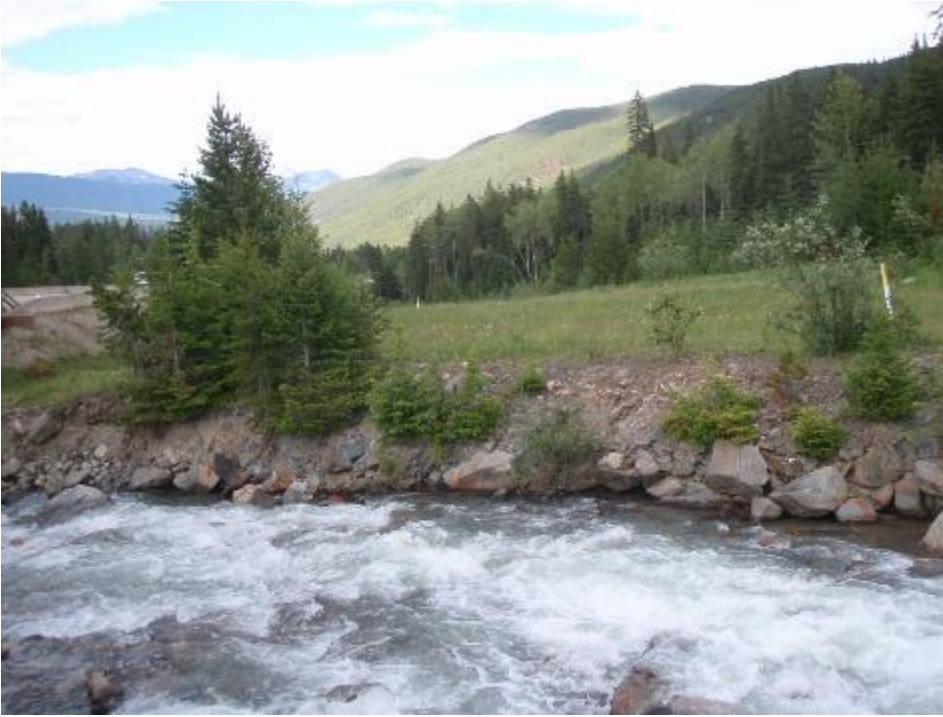
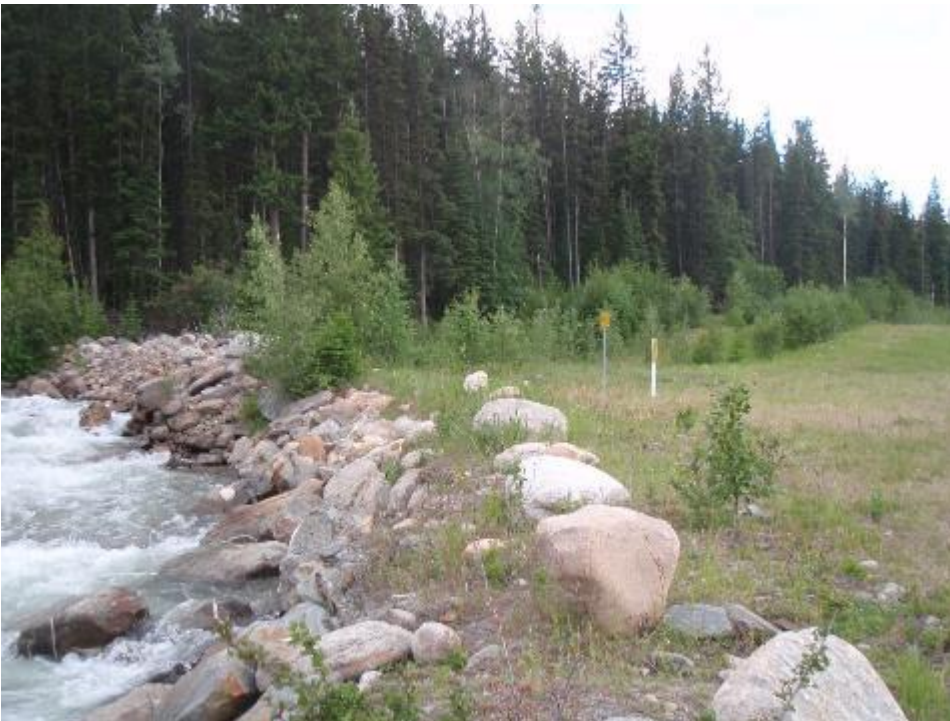
Figure 22 Rockingham Creek, British Columbia, upstream of the highway bridge looking across (top photo) and upriver (bottom photo) at the TMP ROW. Note the destroyed stream banks and almost-complete loss of riparian-habitat vegetation. It is not clear why TMP has been allowed to maintain this habitat in such an extremely degraded state.

The 2004-2008 Anchor Loop project by TMP doubled the pipelines from Hinton, Alberta, to Hargreaves, British Columbia. As seen above, the Jasper National Park section of the pipeline twinning had considerable negative impacts to the aquatic and terrestrial ecosystems in this protected area that continue to be unmitigated. Damage to streams outside of Jasper National Park also occurred as a result of TMP's activities. For example, both the riparian areas and bank structure of Rockingham Creek, British Columbia, were largely destroyed with little habitat mitigation put into place (Figure 22).

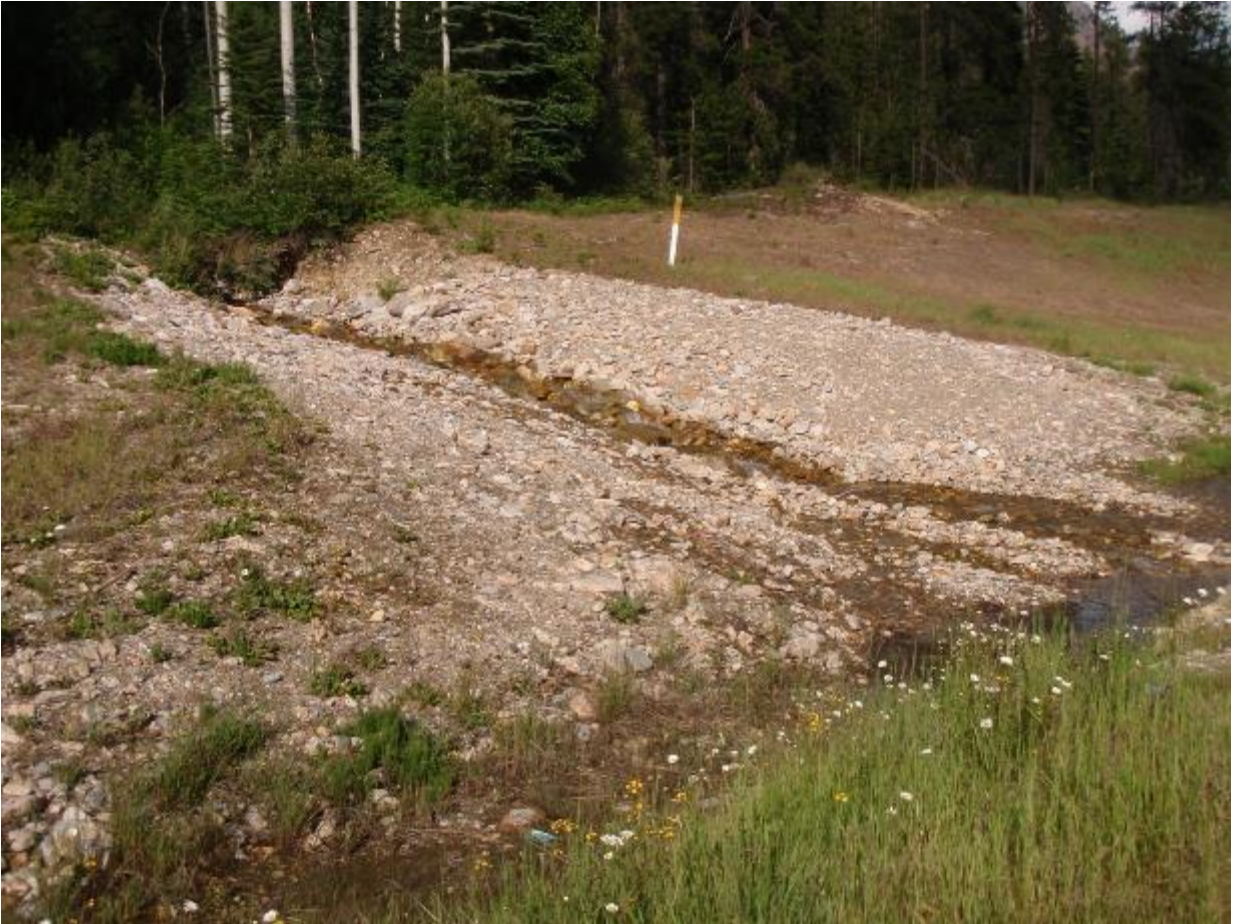
Figure 23 Extreme damage to a stream crossing the TMP ROW. Virtually all habitat capacity has been destroyed in this small stream located west of the Alberta-British Columbia border adjacent to the highway and crossing the TMP ROW. Under any-other circumstances it is incomprehensible that such destruction would be allowed to take place in a CRA-fisheries stream, or a stream that flows into CRA-fisheries waters.

Another example of a destroyed stream within the ROW of TMP, and in British Columbia, can be found west of Rockham Creek (Figure 23). While this may or may not be a CRA fisheries stream, its discharge eventually flows into such a watercourse.
