**Salmon River Enhancement Society**

**Information Request**

**Trans Mountain Expansion Project (Project)**

**Marvin L. Rosenau**

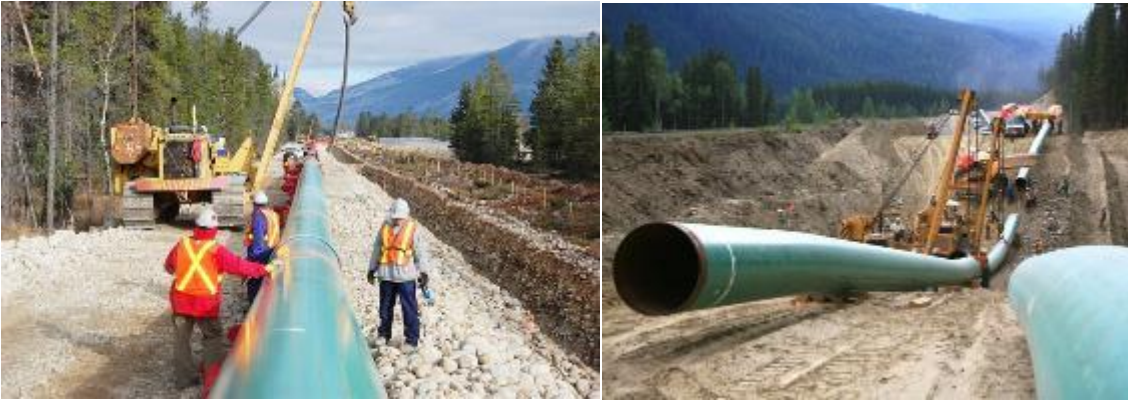
Figure 25 Large-scale ecological devastation of the landscape for both the existing ROW and construction zone when laying pipelines. When constructing petroleum pipelines, the vegetation is typically stripped in both the ROW and the construction zone, the landscape is compacted by machinery and all natural ecological function is destroyed. Left photo: <http://www.vancouversun.com/business/things+know+about+Kinder+Morgan+pipeline+protest+Burnaby/10400385/story.html> Right photo: <https://financialpostcom.files.wordpress.com/2013/12/transmountain.jpg?w=620>

In large part, the combined TMEP construction and right-of-way (ROW) corridors will entail destroying a vegetated width of approximately 45 m. This comprises both the permanent ROW (18.3 m) and the “temporary” construction zone (26.7 m) (Figures 24, 25). We use the term “temporary” in this context in quotes as, from our experience in the Anchor (Jasper National Park; Mount Robson Provincial Park) Loop in Alberta, these impacts to the construction zone last far longer than a decade and, for-all-intents-and-purposes, are going to be largely permanent within the lifetime of the project.

Similar to the generic vegetation removal for the terrestrial portion of the TMEP, for these streams the expected disruption of the riparian area is approximately 45 m wide, including 18.3 m for the existing ROW and 26.7 m for the construction zone (c.f., Figures 24, 25). For stream crossings, of course, there will be an impact to riparian areas on both the stream banks.

Significant amounts of vegetation will be removed as a result of the corridor clearing for TMEP for both the ROW and construction zones (Figure 25). This will include both riparian and terrestrial landscapes and, in addition, to other, lesser-footprint-area, removals (e.g., pumping stations). For the most part, the clearing will comprise a corridor width of ~45 m of which 18.3 m will be the ROW and 26.7 m will include the construction zone (Figure 24).

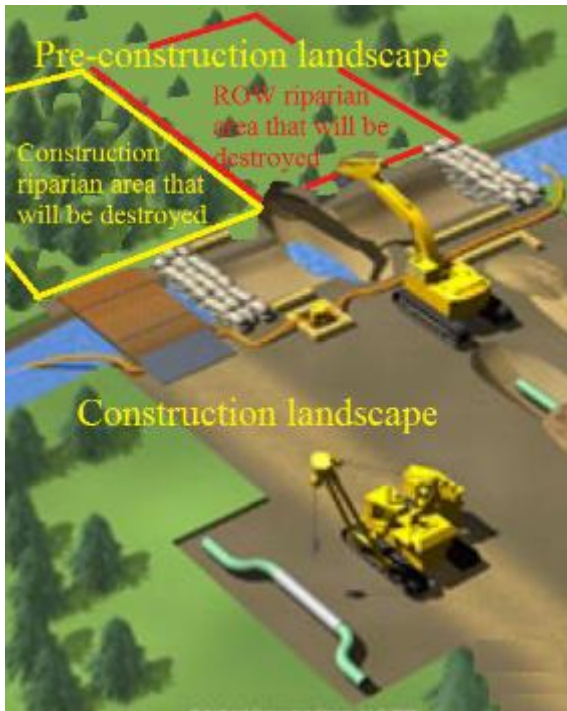
Figure 26 Pipeline construction across a stream using trenching methodology as proposed by Trans Mountain Expansion Project for most of its stream crossings.

Trans Mountain Pipeline (TMP) indicates that there will be approximately 249 stream crossings in British Columbia that are habitats for fishes of commercial, recreational and aboriginal (CRA) interests. For stream crossings, Trans Mountain Pipeline (TMP) has largely proposed trenched crossings (Figure 26), as opposed to trenchless (Figure 27). Confirmation of this information can be reviewed in the TMEP/Triton Environmental Consultant's self-evaluations of *Serious Harm* for British Columbia CRA streams. Note that the TMEP/Triton Environmental Consultant's refusal to engage in the use of trenchless crossings is contrary to the Oil & Gas Commission's recommendations for stream crossings with fish (Figure 8). It is not clear why TMP is deliberately ignoring the Oil and Gas Commission's expectation for stream crossings through watercourses containing fish. Trenchless crossings have the potential for protecting riparian habitats. For its habitat-impact self-assessments, TMP has publically stated that it does not consider the destruction of riparian habitats in its TMEP to constitute *Serious Harm*.

Vegetation in both the ROW and construction zone, including the riparian areas, are completely destroyed using this method (c.f., Figure 5). The environmental proposal documents for the Trans Mountain Expansion Project indicate that TMP plans to use trenching technology for most stream crossings with no meaningful restoration or compensation for this critical aquatic habitat feature.

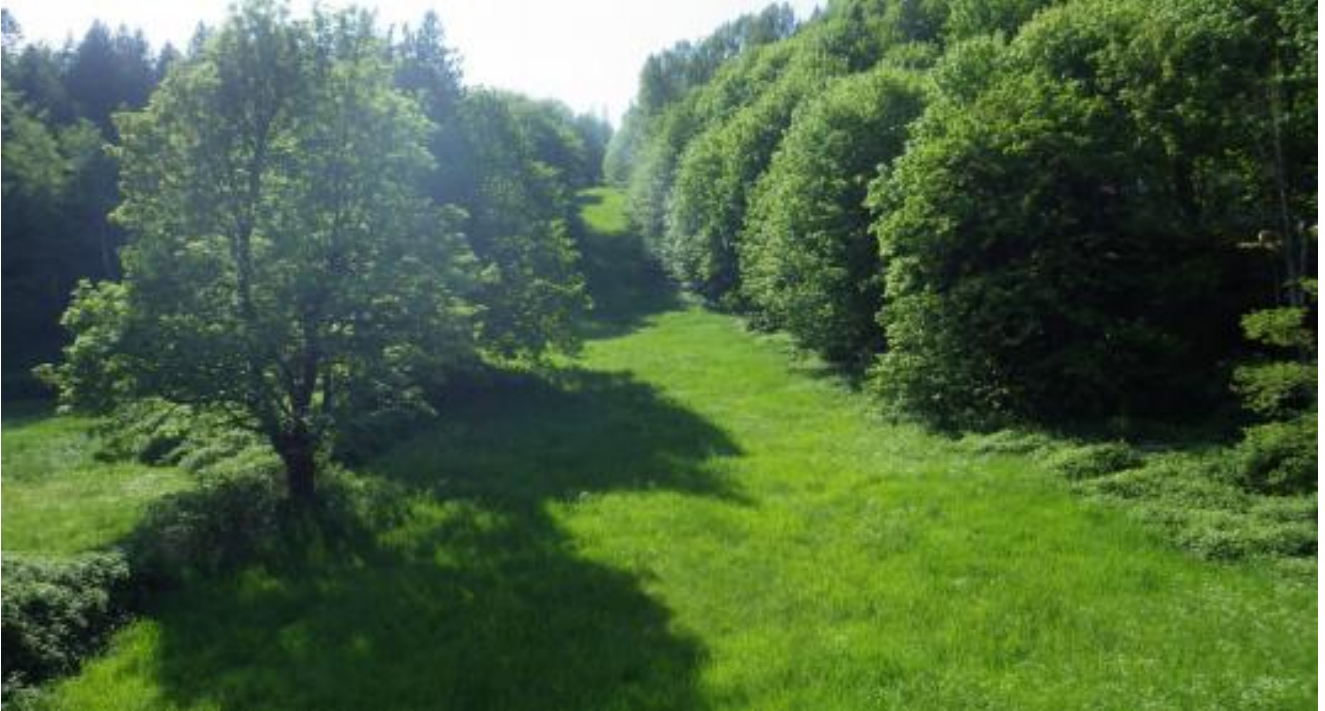
Figure 30 Groomed ROW of the Trans Mountain Pipeline just west of the Vedder Canal, looking west, with the loss of almost all natural ecosystem attributes including large trees. Note that no large vegetation is permitted to grow on the ROW. This includes riparian areas at stream crossings. During the TMEP many of these trees will likely be lost at this location as a result of the clearing for the construction zone of the corridor (depending on the alignment). Based on the experience of the Anchor Loop, and conversations with the vegetation specialist in the May 19/20, 2015, there is no indication that TMP is prepared to mitigate or compensate for this aspect of ecosystem losses. (see also [http://www.transmountain.com/uploads/pages/1409251834-PIPELINE\\_EPP.pdf](http://www.transmountain.com/uploads/pages/1409251834-PIPELINE_EPP.pdf) ).

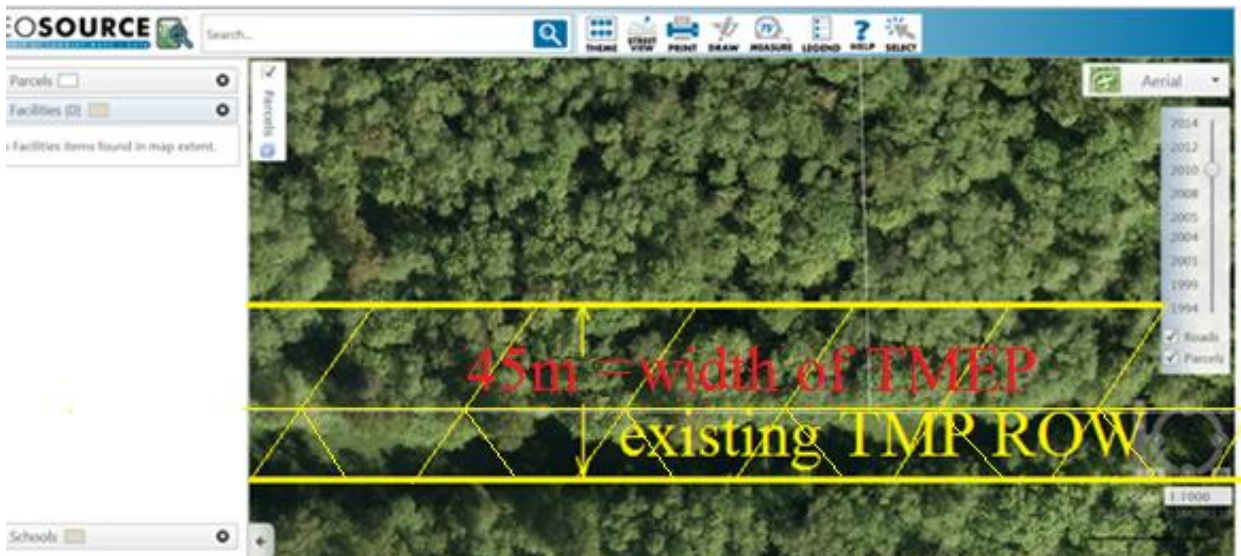
Figure 31 Air photo of the TMP ROW in the Township of Langley areas. Extensive losses of large second-growth vegetation in the Township of Langley area that will occur as a result of TMEP. This location is a short distance from the intersection of Nathan Creek and the existing TMP ROW, which was constructed in 1953. Note that the TMEP will clear these trees as part of both the ROW and construction zone (Figure 4). Adapted from: <http://geosource.tol.ca/external/> and accessed April 4, 2015.

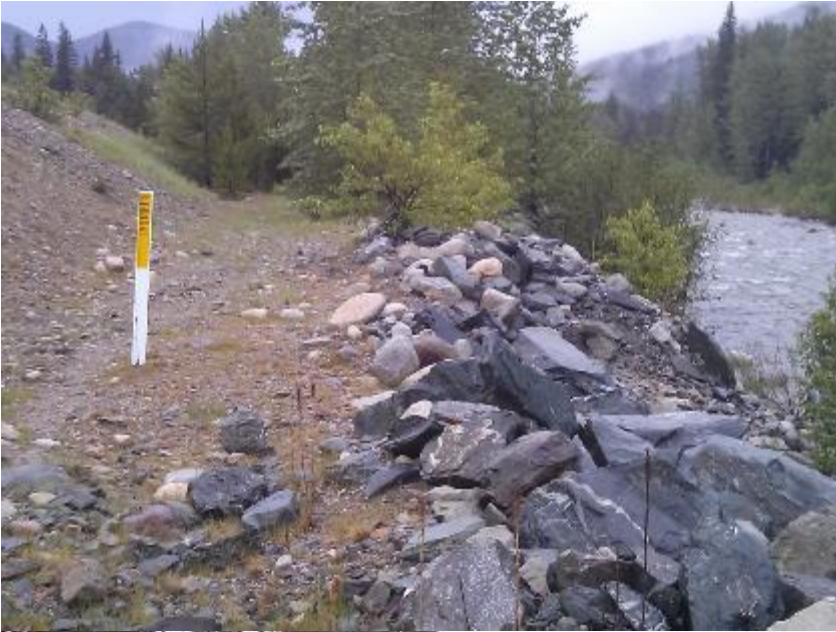
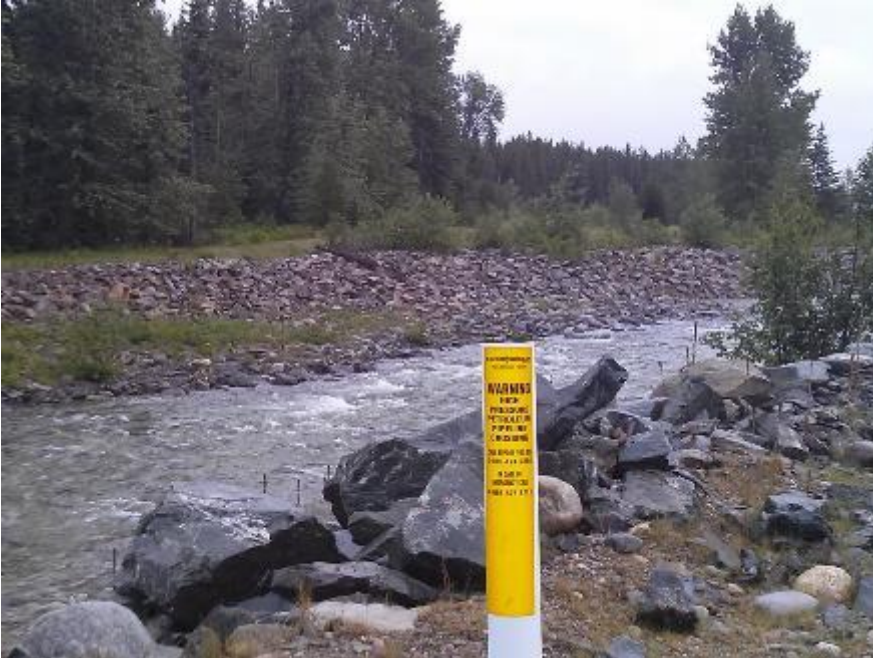
Figure 40 Extensive and extreme damage to the shoreline habitat of Juliet Creek on the Coldwater River drainage due to rip rapping, channelization and vegetation removal at the TMP crossing. Top photo: on left bank, looking downstream; Bottom photo: on left bank looking cross stream. Photos taken May 2015.
